# Commercial Fish Farming Project in Nigeria

Research and Development Series No. 30

May 1983

International Center for Aquaculture

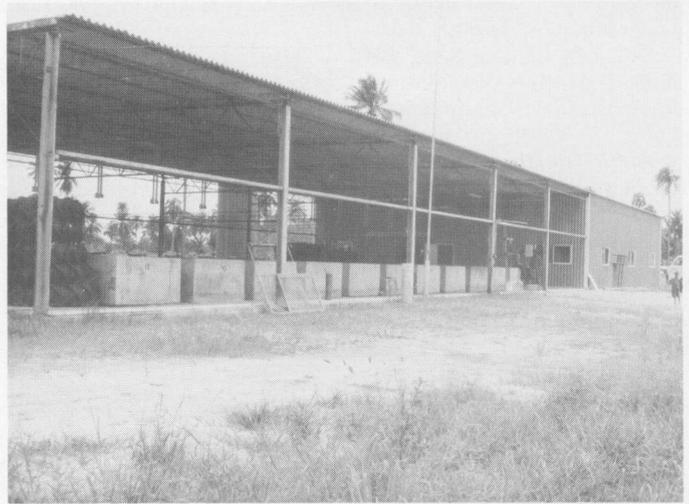
FIG. 4. TOP—fish holding and hatchery building; BOTTOM—close-up showing fish holding tanks in foreground and office in background.

The headquarters facilities consist of a large (50 x 160 feet) fish-holding and hatchery building, figure 4. The building is enclosed at one end with aluminium siding. This enclosure houses the office, the wet-lab, and storage for small hardware and supplies that require shelter. It also houses four concrete tanks (3 x 3 x 25 feet) that are to be used for indoor breeding and fry-rearing purposes and other specialized hatching and incubation facilities.

The rest of this structure is an open shed in which there are 11 fish holding tanks measuring 4 x 3 x 45 feet. Each tank has an independent water supply and drain, and a walkway along each side to facilitate fish seining, treatment, size grading, and other procedures.

The entire building is supplied water by steel lines embedded in the concrete slab. Water of low hardness is supplied from a bore-hole or well at a rate of 800 g.p.m. The submersible well pump is powered by a 240-volt generator rated at 162 KVA (129 KW) power output. Water is discharged into a 5,000-gallon elevated surge tank, from where it flows by gravity to the facility. Water level in the tank is controlled by an automatic mercury switch. This system will also furnish water to the housing, shops, and work area.

The construction of the fish holding hatchery building is that of conventional pre-fabricated metal buildings, with a 6-inch concrete slab floor. A 6,000-square-foot slab could be poured in one piece in one day by conventional equipment and methods in the United States. With only one 1/4-cubic-yard concrete mixer available at the project site, it was possible to pour only one strip 10 feet wide across the 50-foot dimension of the building per day. This required 15 "cold-joints" in the overall length of the slab. In order to strengthen and enhance the integrity of the slab, the normal procedure of joining individual slabs by smooth butts was modified.

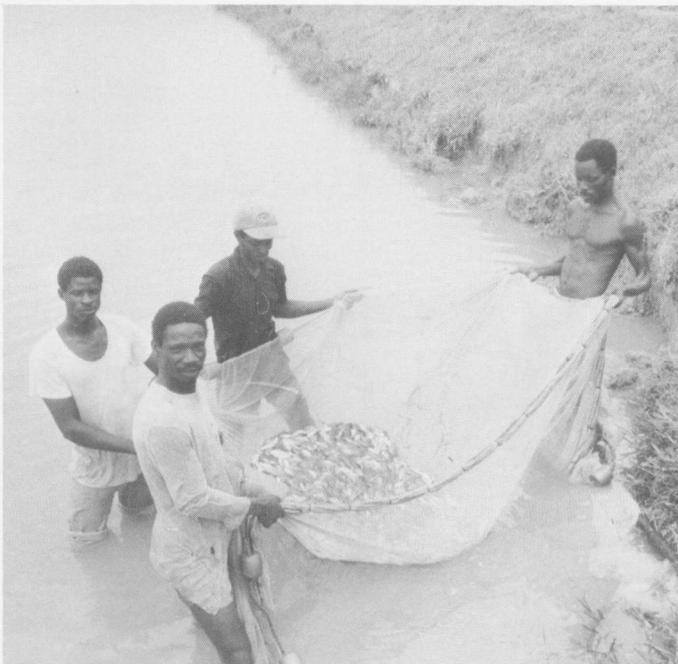
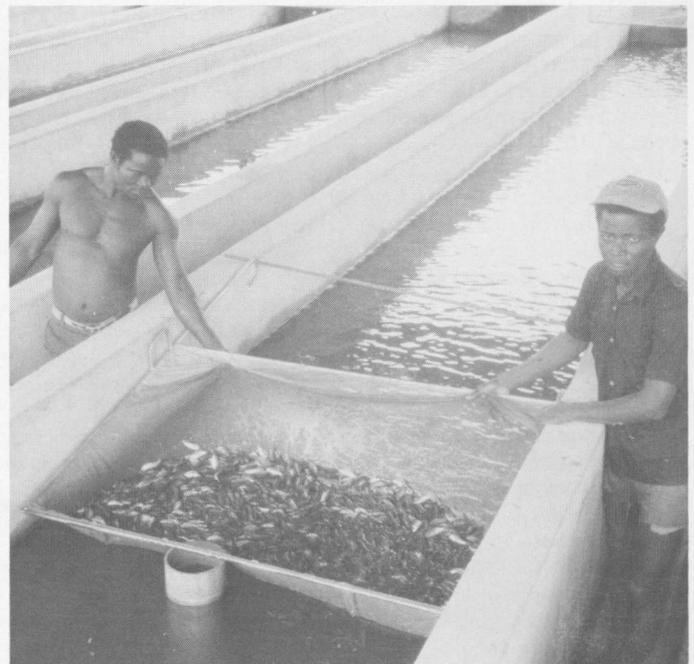
**FIG. 7. LEFT—harvesting fish fingerlings from "fish seed" pond; RIGHT—selecting fingerling fish from concrete holding tanks prior to stocking grow out ponds.**

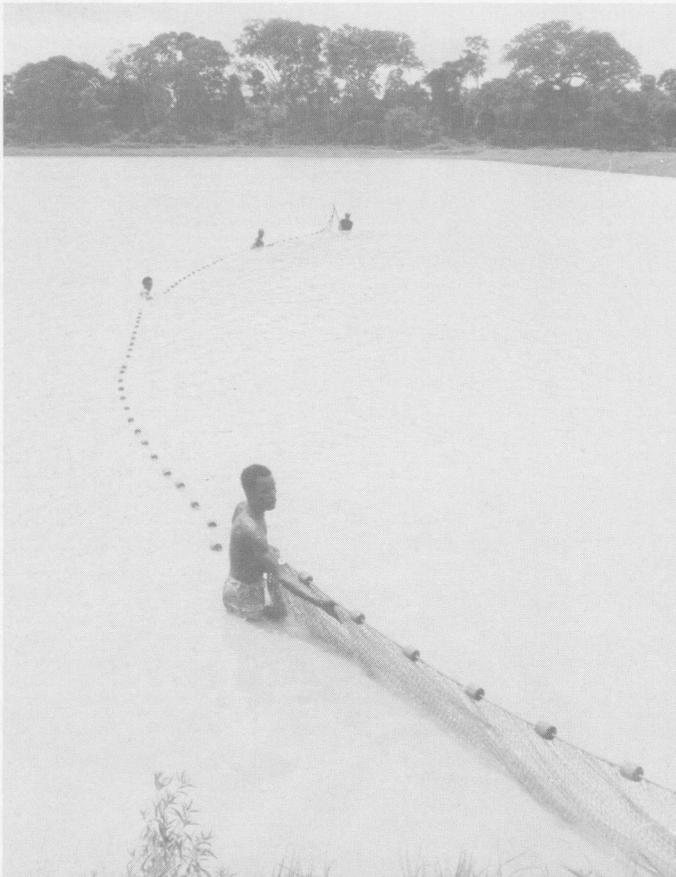
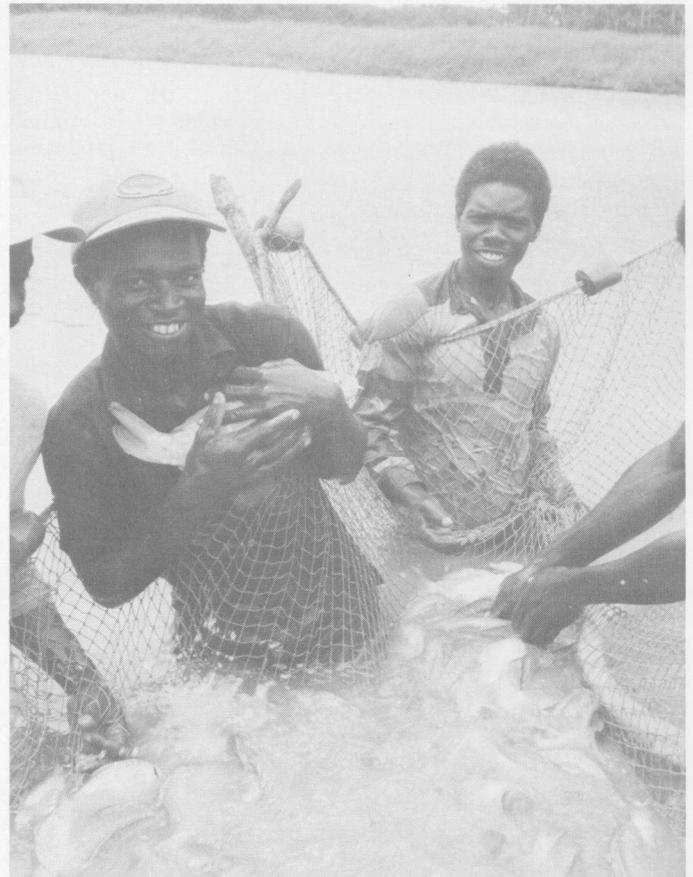
**FIG. 8. LEFT—seining operation in production fishpond to obtain fish for market; RIGHT—net of harvestable size fish being prepared for market.**

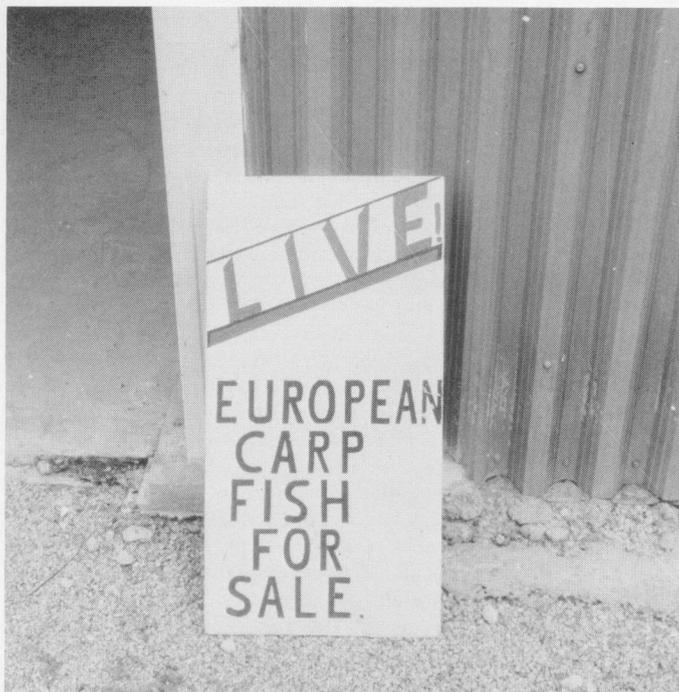
**FIG. 9. LEFT—fish are sold live in Nigeria because of higher price and greater demand; RIGHT—fish are maintained in live-holding facilities for retail sales at the fish farm.**
